Information on structural damage to condo buildings

Water damage behind cedar siding causing dry rot, moisture issues, and deterioration of buildings

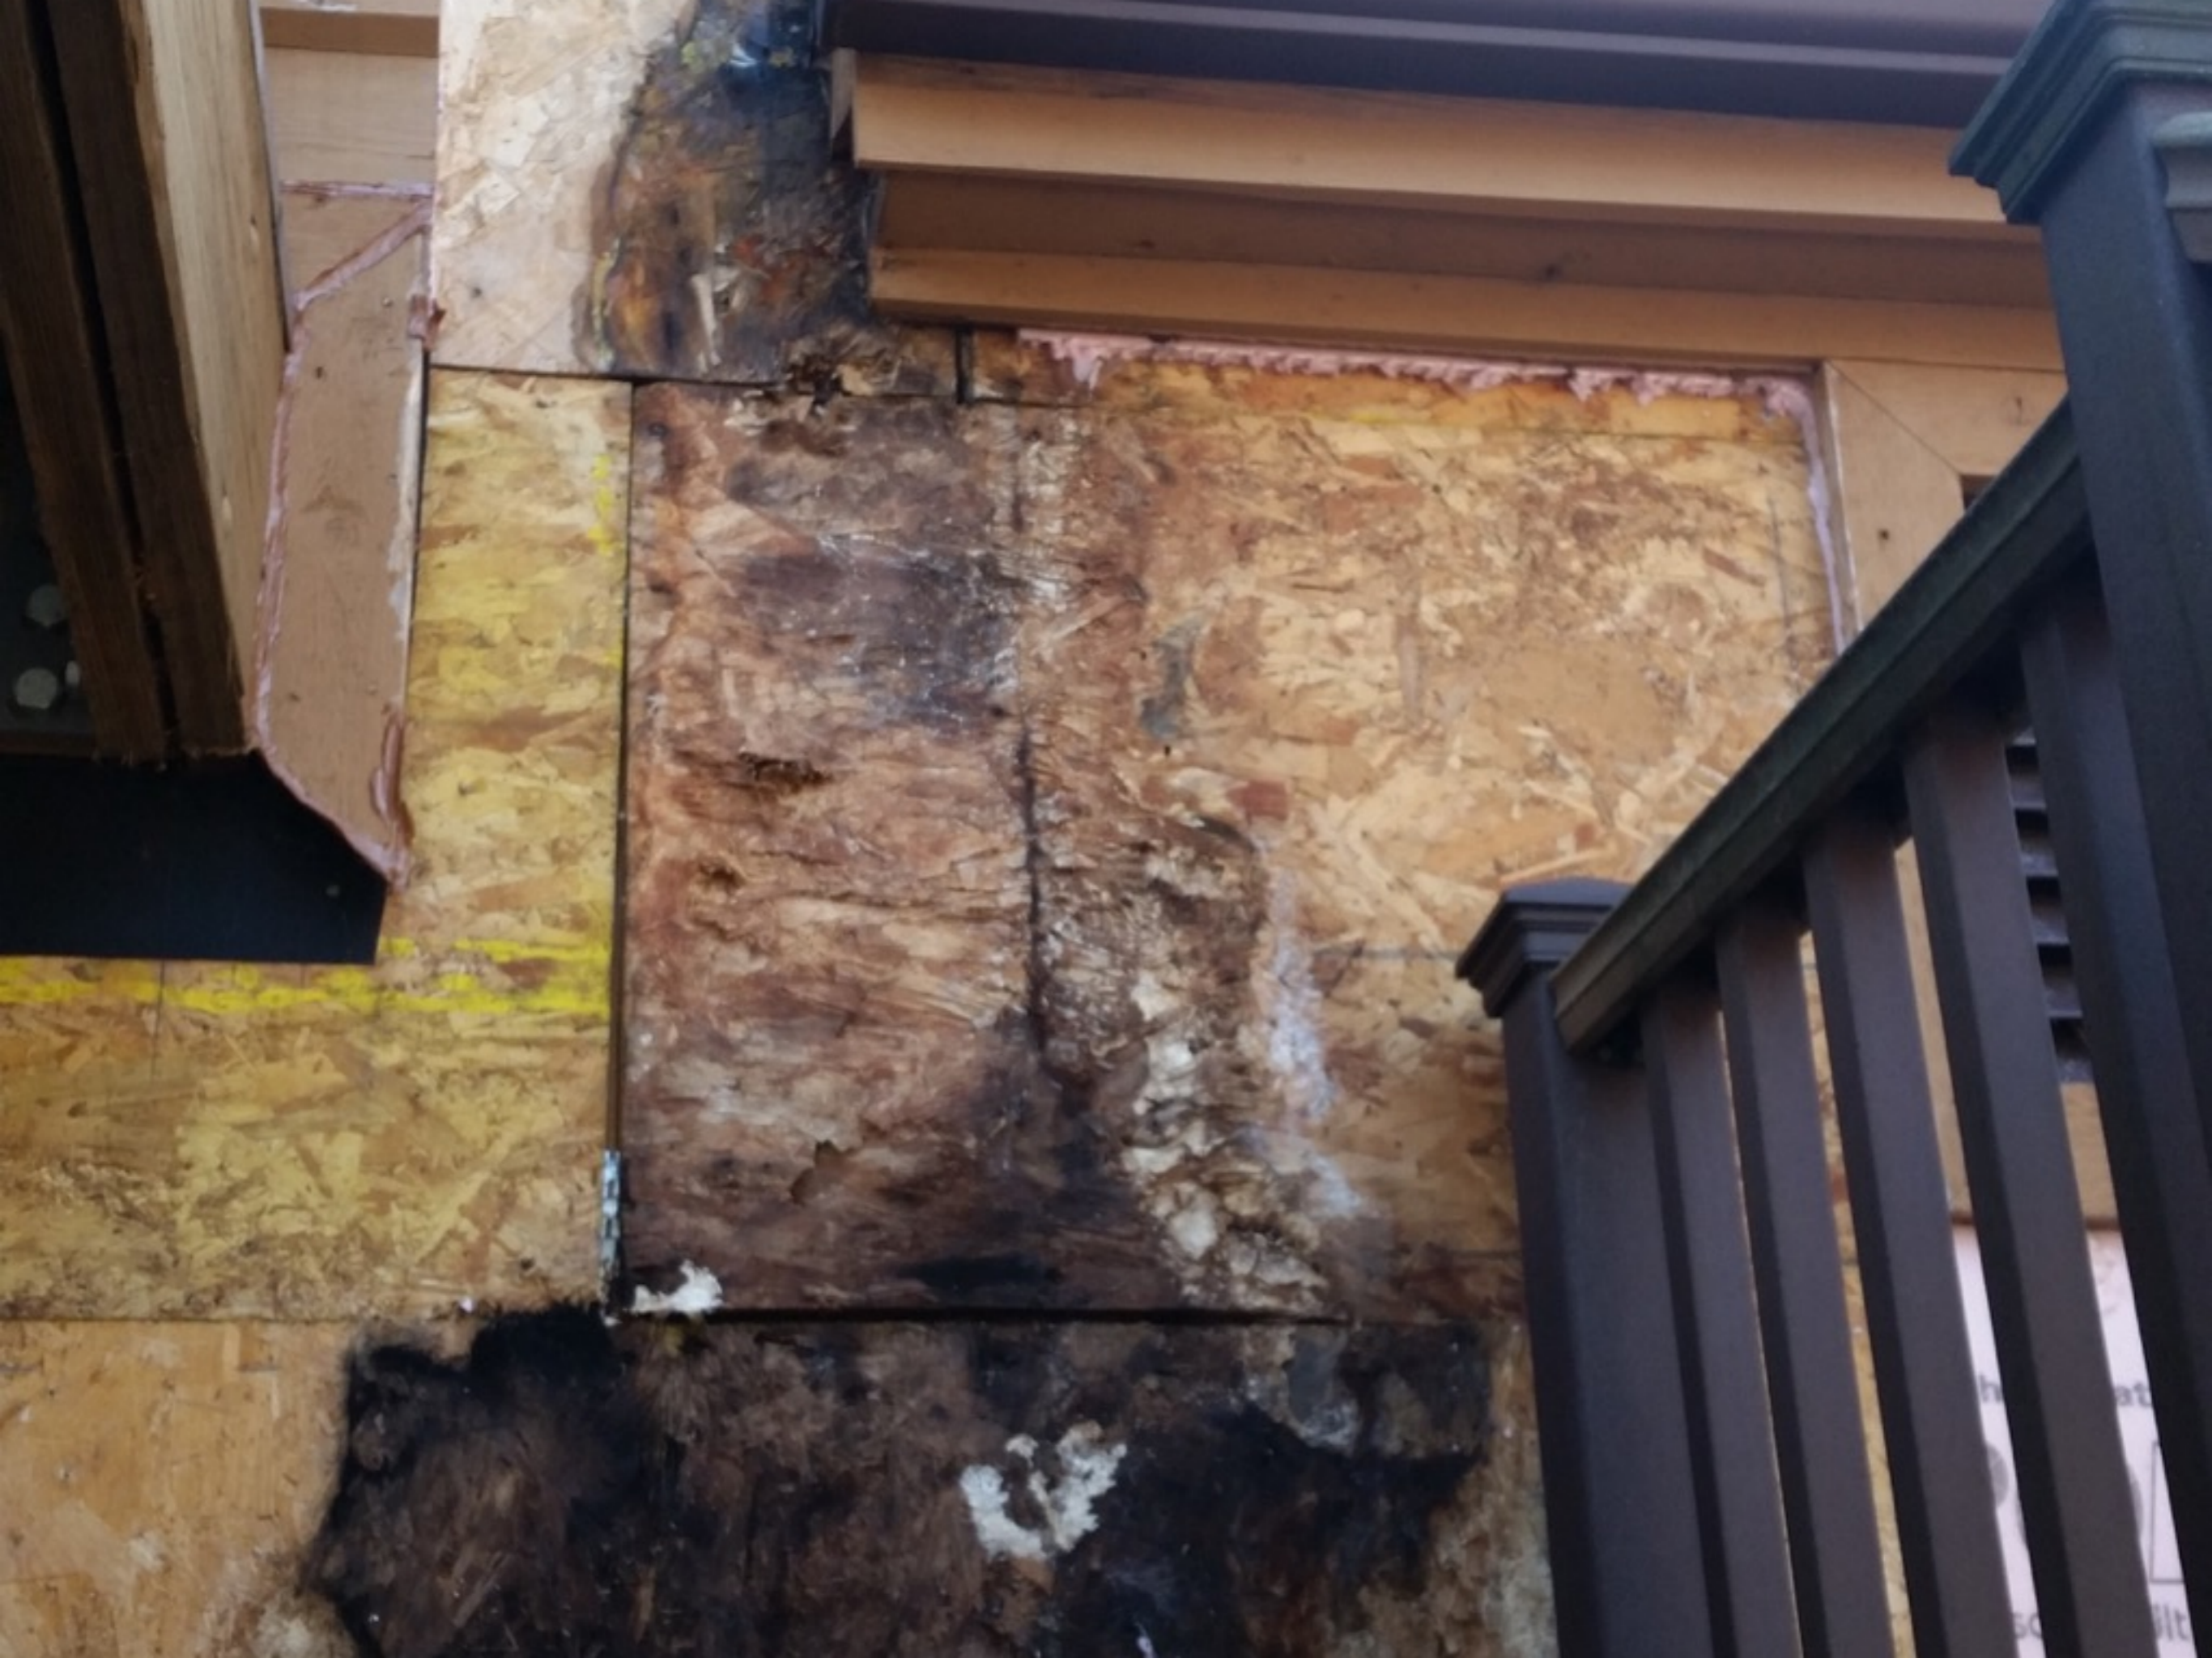
Building 23

Water damage
