May 5, 2016

Re: Sunset Bay Condos  
GEC # 2-0216-78

I inspected Building 23 at the Sunset Bay Condos on May 3, 2016 and the results of my inspection are as follows. I was asked to design a repair for some rotted second floor trusses that were found during the siding removal. I will work on having a repair for these trusses as soon as possible so the construction can continue.

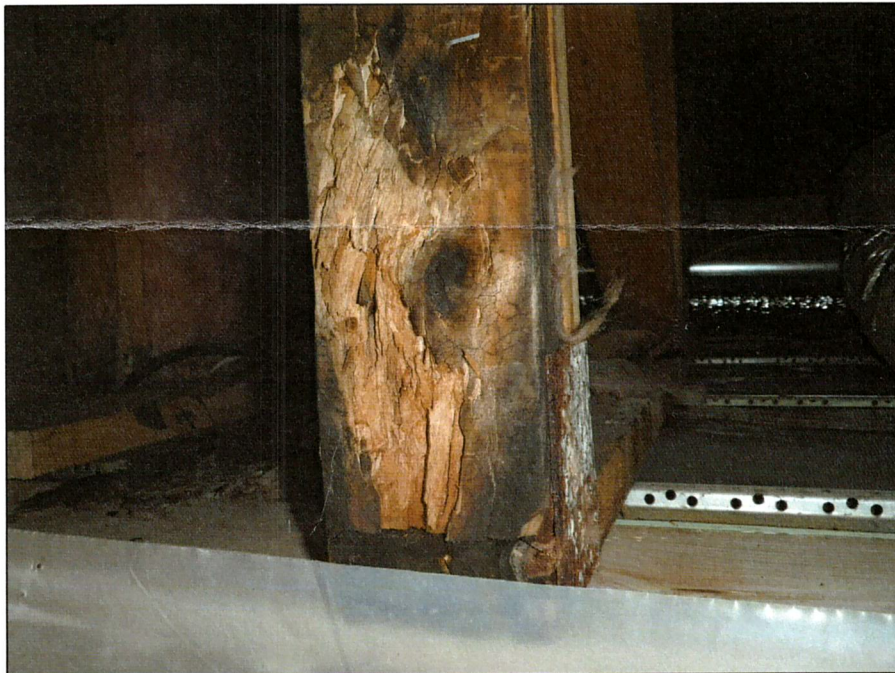
Rotted Floor Truss

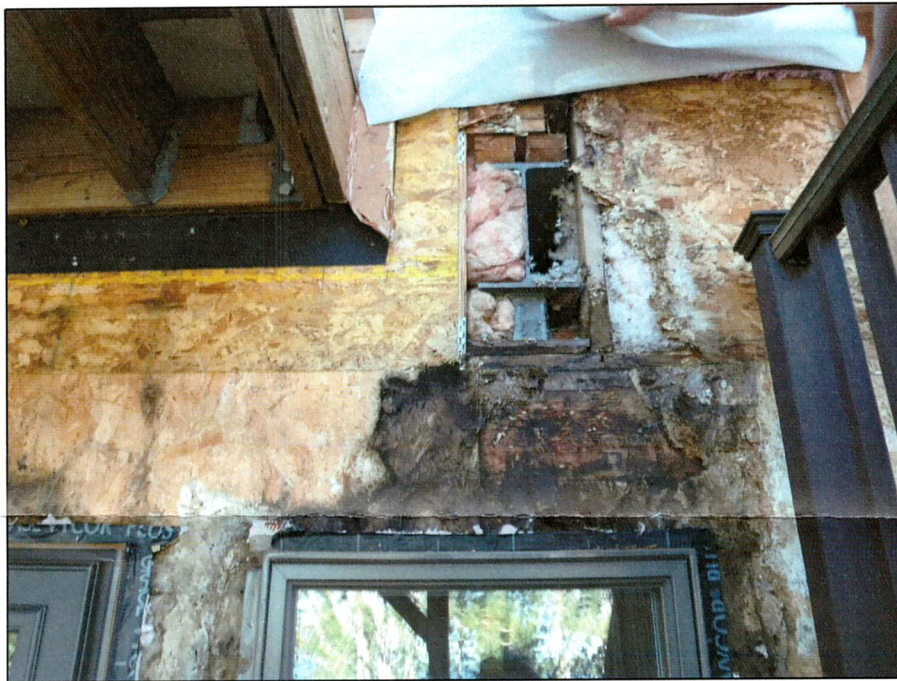
While on site, I found more areas that represent a severe structural concern. The biggest issue that was found is that there are steel beams that bear on the back wall above the rotted headers. The support system for this steel beam has been compromised and this steel beam supports the third floor and roof. If this header were to fail, then the only thing supporting the end of the beam is the window. Failure of this header has the ability to collapse parts of the third floor and roof in this area.

Steel Beam Bearing On Rotted Header

It is my understanding that there is a condo owner that does not feel that all of these repairs are necessary, especially in the near future. I disagree that this is a repair that can wait. If the rest of the building looked like the back wall of Building 23, then it is only a matter of time before there is a structural failure. In their present state, the support of the decks is compromised, the support of the steel beams is compromised, and the lateral restraint system that keeps the building vertical in a high wind situation is compromised. The studs, wall sheathing, and headers on these back walls can be crumbled in many places with your bare hands. Leaving these buildings as they currently are, is a huge safety and liability issue.
