**INSPECTION REPORT
FOR
SUNSET BAY CONDOMINIUMS**

APRIL 2016

GENERAL ENGINEERING COMPANY

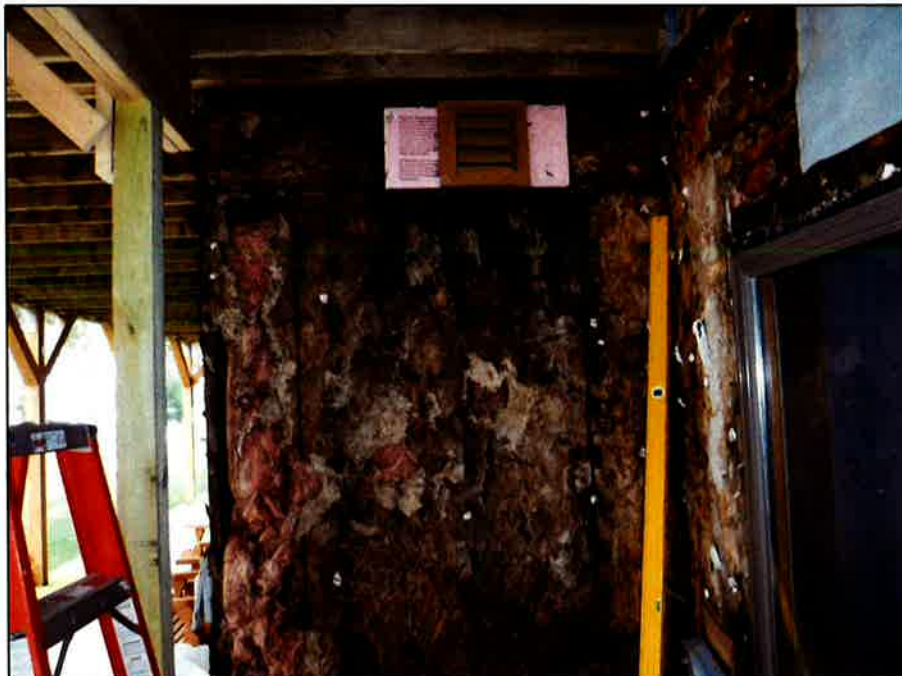
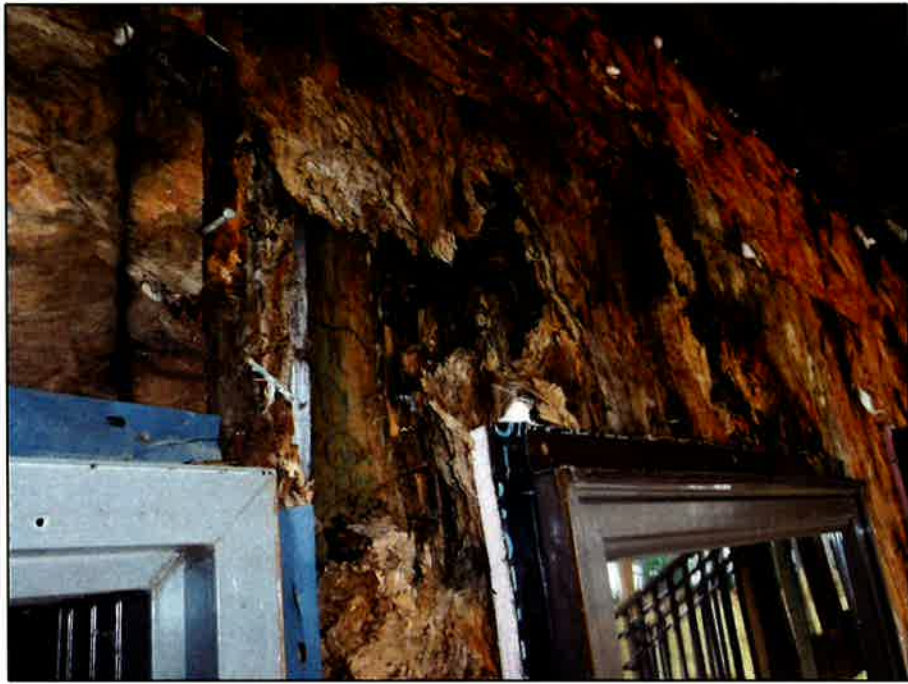
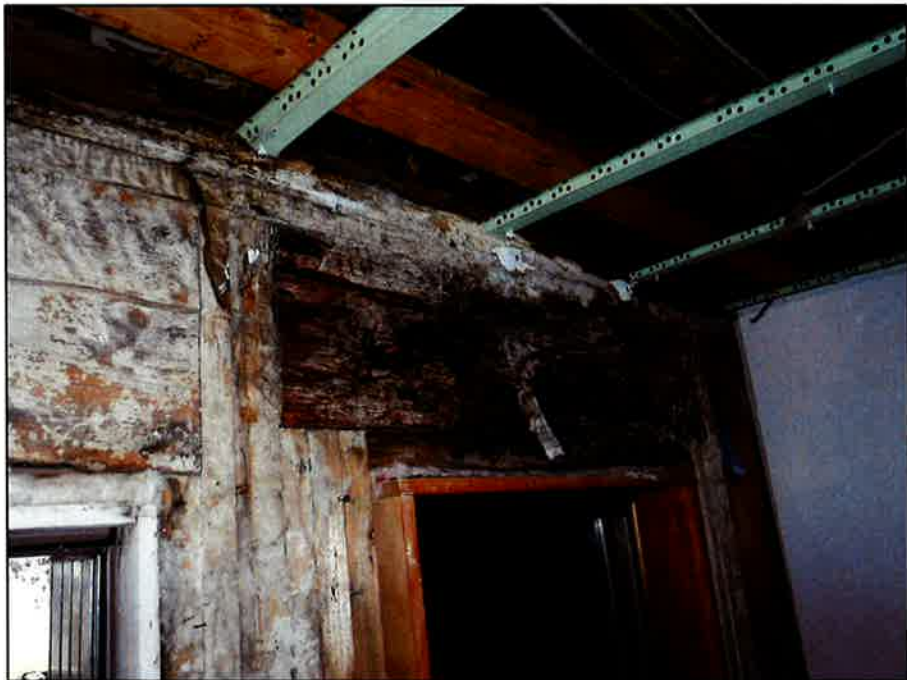
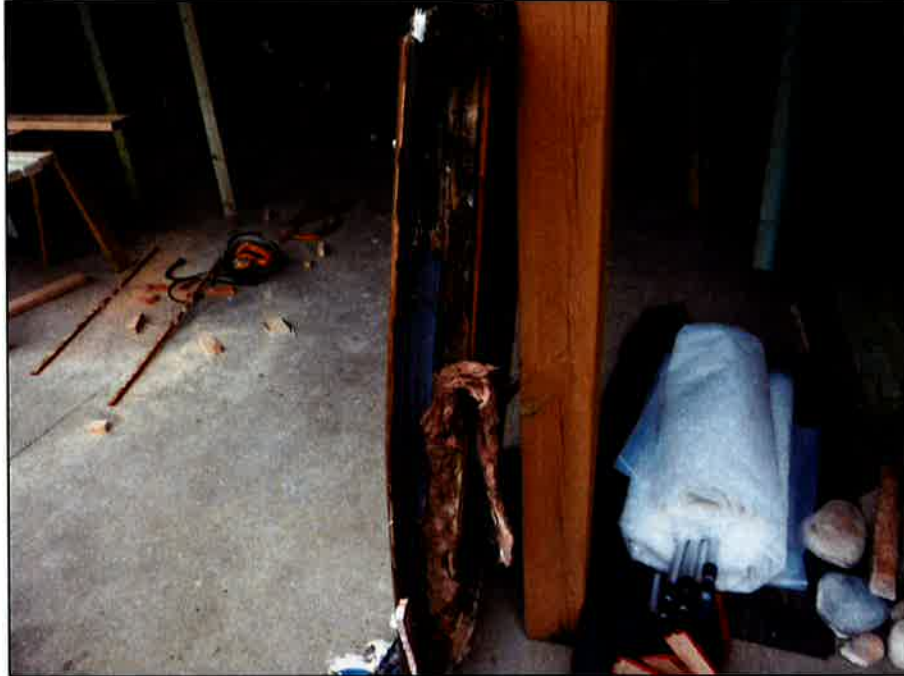
When I arrived at the building, the contractors had removed the siding and drywall from the lowest floor on Building 23. The siding was removed from the west side of the building on the south end of this side. What I found is that the wall sheathing and studs were rotted across the short jog in the back wall all the way to the southwest corner of the building. The rotted members included much of the wall sheathing, many of the studs, parts of the windows and door headers, and parts of the truss located between the first and second floor. The headers in this area consisted of either dimensional lumber or LVL. All three of the headers in this area were rotted sufficiently to warrant replacement.

From what I could see, the contractor was doing a very good job of systematically repairing and replacing the degraded walls and wall framing so as not to cause additional damage to the rest of the building. As these areas are reconstructed, it will be extremely important to make sure that all of the weatherization components are dealt with appropriately. This includes the installation of Tyvek, Tyvek flashing tape around the windows, deck flashing both above and below the ledger boards, window and door flashing, and proper flashing on the roof. I would strongly recommend replacing all windows on this side of the building, even if they are somewhat salvageable.

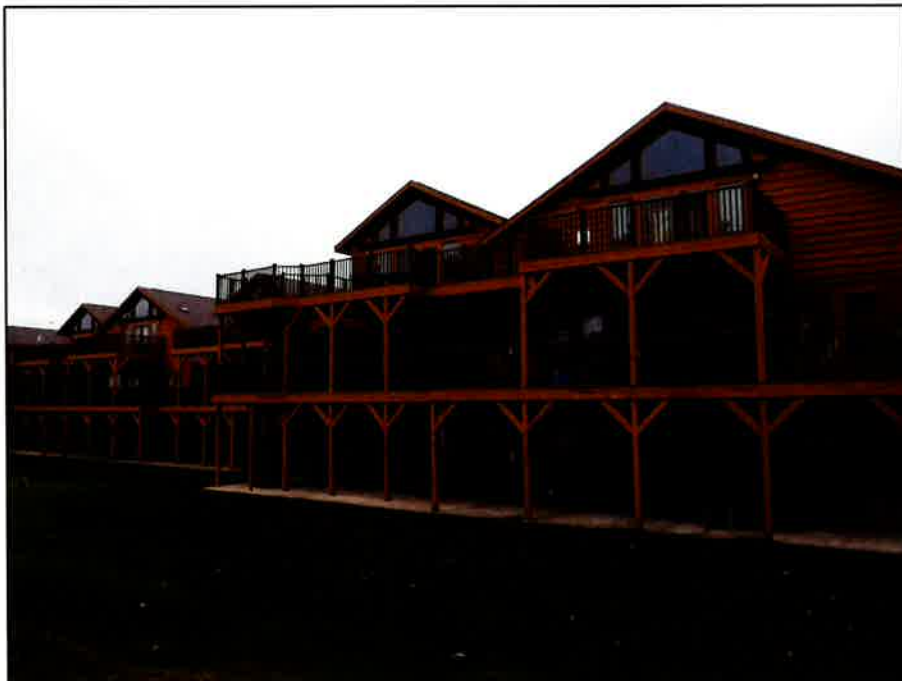
From what I could see, the rot extends the back of the building where there was a deck installed. As you can see in the next picture the decks span across most of the back sides of the buildings. Until last year, it was reported that the back walls leaked every time it rained. At that point, deck flashing was installed and the leaks reportedly diminished greatly. It is my opinion that the deck flashing, had it been installed properly when the buildings were first constructed, would have eliminated a large amount of the issues.

You have significant rotting on the condo buildings in all the areas where decks were attached to the walls. This is most prevalent where the decks face the water and caught the water born wind off of the lake. All this water hitting the building and running down to decks which did not have deck flashing in my opinion caused the majority of the rot on these buildings. The window and door openings around the rest of the building also have rotting issues because of a lack of flashing.
